# COVERED CONDUCTOR KEEPS POWER FLOWING SAFELY

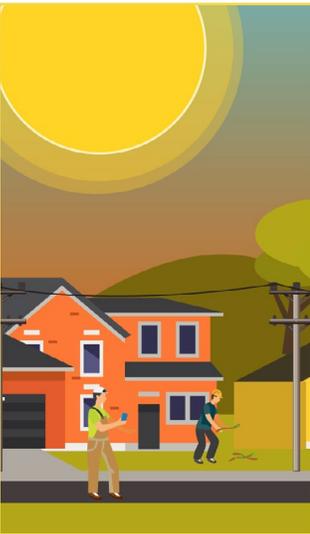
In the instances shown to the right, branches landed on covered conductor, but because the wires are insulated, these strikes did not cause a fault or sparking on the circuit. The wires performed as designed, reduced the risk of wildfire and customers did not have to experience an outage.

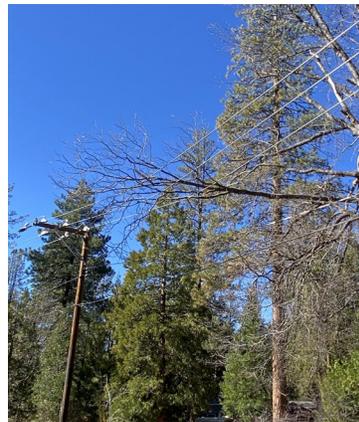
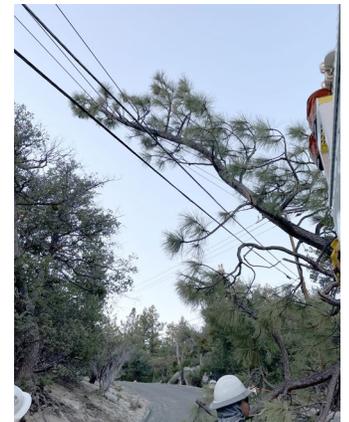
*Inspection photos show tree branches that had fallen onto insulated wires (covered conductors). Power remained safely on for customers in the Idyllwild area of Riverside County-November 25, 2021.  
Credit: Trenton Koury*
